TEST CERTIFICATE No.: INZ81355-01

Test: Repetitive pull-out load test and a single shear test on the Stratlock® Range plastic mounting system to determine performance and capacity.

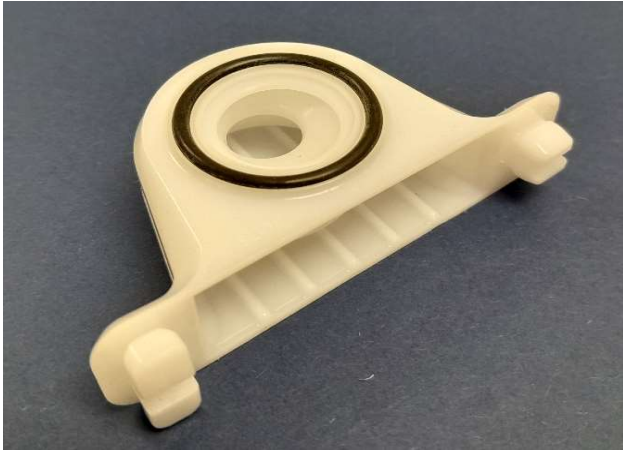
Figure 1 - SL-FA female clip

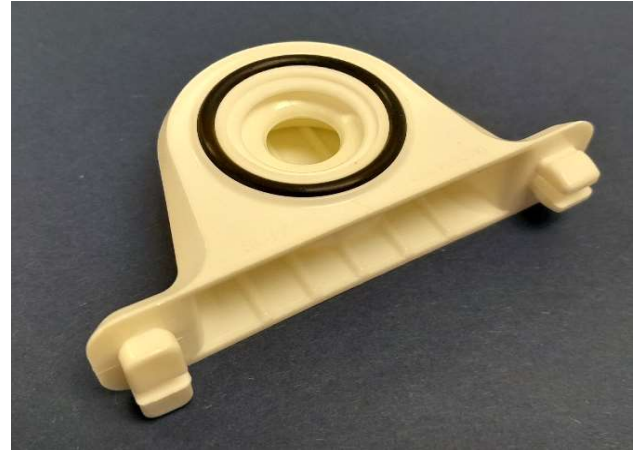
Figure 2 - SL-FA-FR female clip

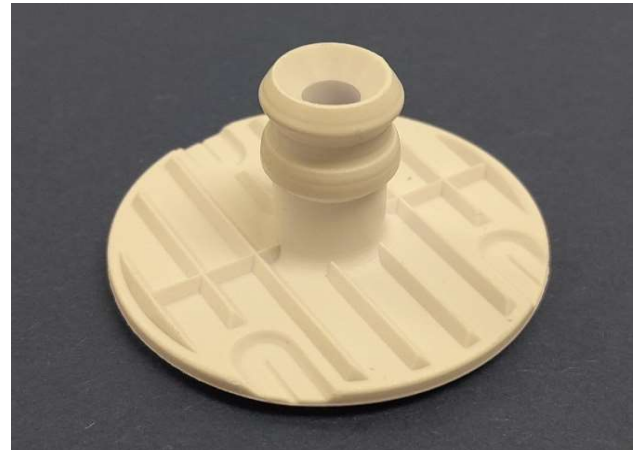
Figure 4 - SL-M18 male clip

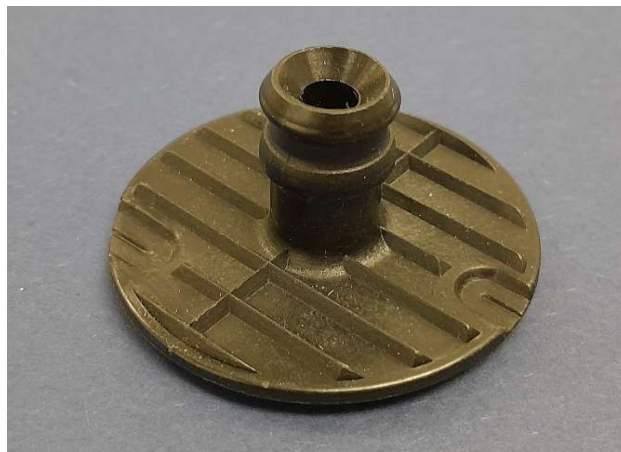
Figure 5 - SL-M18-FR male clip

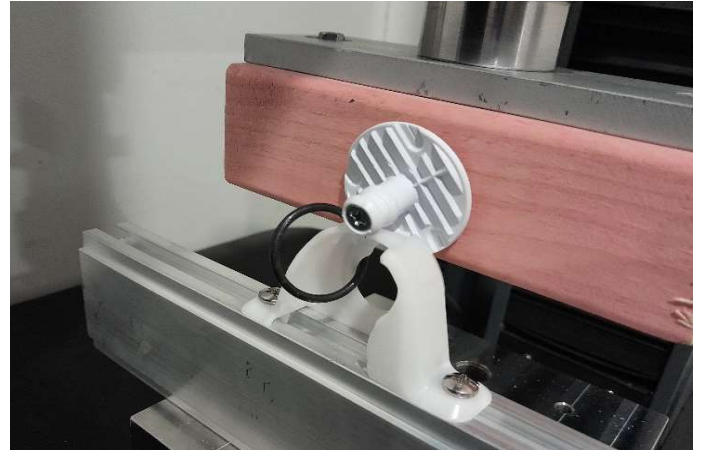
Figure 8 - Fracture of female clip housing

Figure 9 - Fracture of female clip housing

Female / Male Clip	Pull-out Force (Kgf)		Shear Force (Kgf)	Comments
	Initial	After 500 Cycles		
SL-FA / SL-M10	18.4	18.5	88.9	Pull-out capacity remained consistent over 500 cycles. Both the male and female clips deformed under shear but ultimately failure occurred from the fracture of the female clip housing.
SL-FA / SL-M18	29.4	19.9	123.1	Pull-out capacity suddenly decreased by 10 kg after ~100 cycles then remained consistent thereafter. Both the male and female clips deformed under shear but ultimately failure occurred from the fracture of the female clip housing.
SL-FA-FR / SL-M18-FR	24.7	6.7	131.0	Pull-out capacity decreased by ~18 kg over 500 cycles. This decrease was due to wear of female clip. Both the male and female clips deformed under shear but ultimately failure occurred with the 8G screw pulling through the timber.

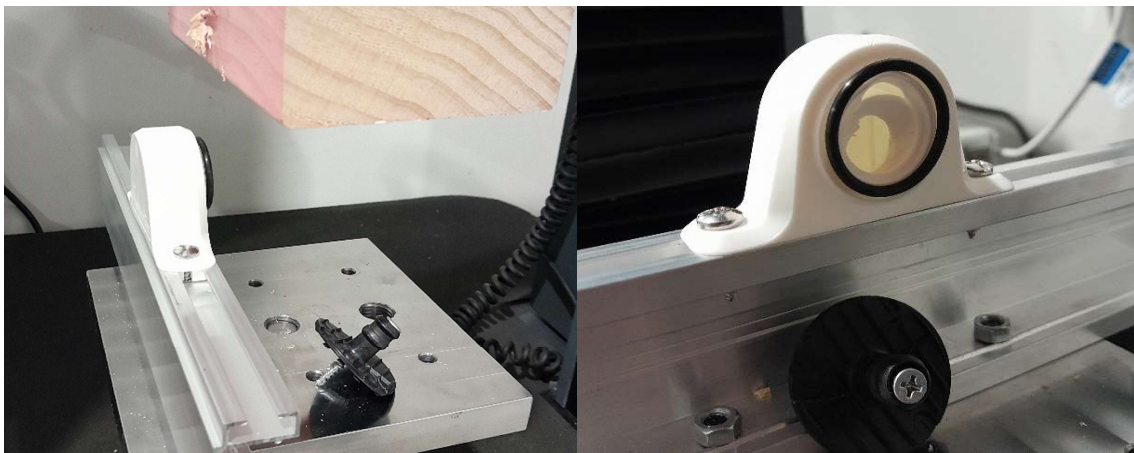
Figure 10 - Pull-out of 8G screw from timber substrate

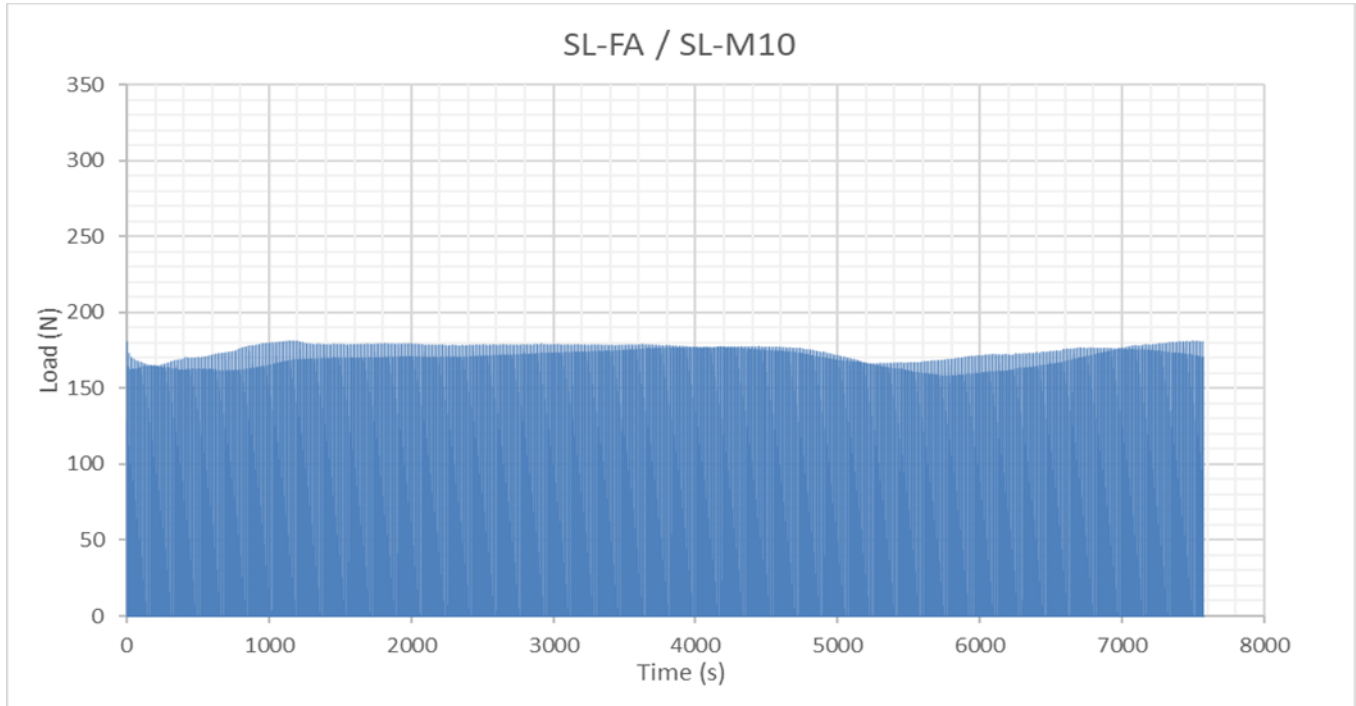
Figure 11 - Graphical representation of the SL-FA / SL-M10 clip set pull-out test

The plastic clip set was subjected to cyclic pull-out loading at a rate of 100mm/min with a frequency of approximately 1 cycle per 15s. The initial pull-out force was measured and recorded and then again after 500 cycles. Graphical representation of pull-out behaviour shown in figures 11 to 13 with the test setup shown in figure 6.

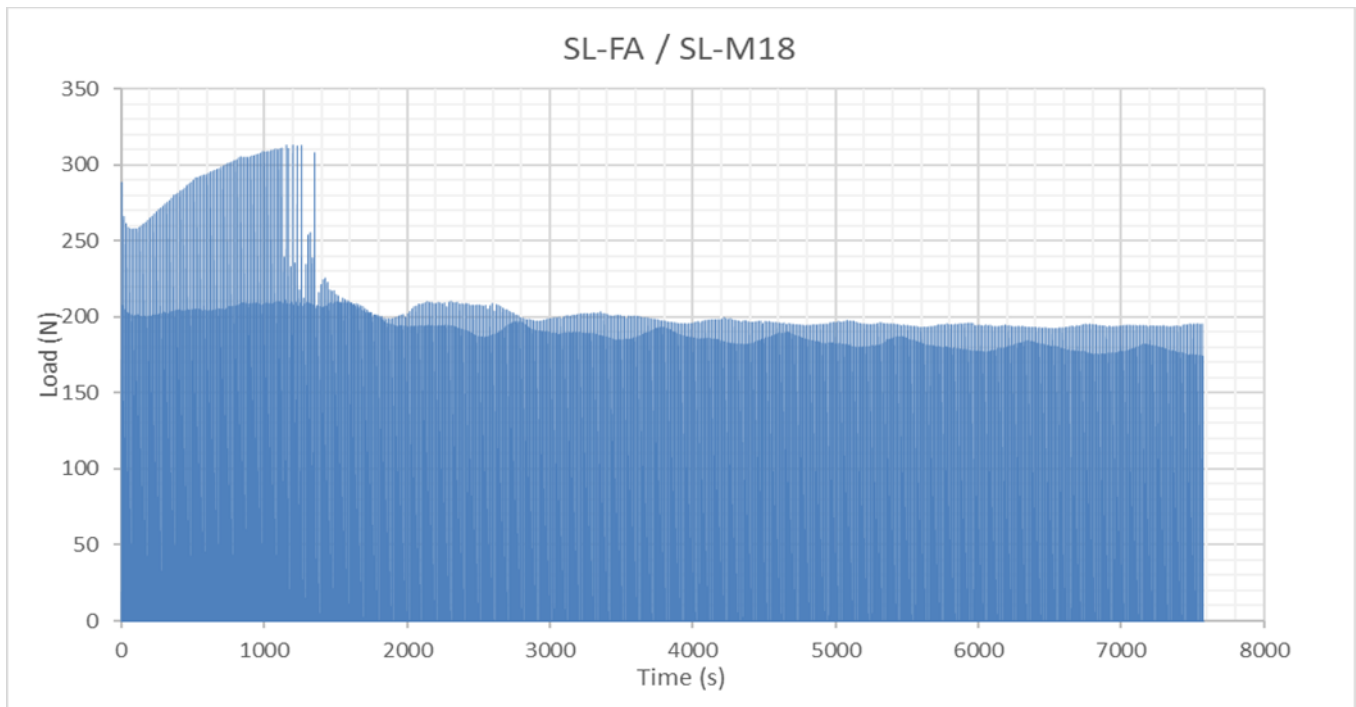
Figure 12 - Graphical representation of the SL-FA / SL-M18 clip set pull-out test

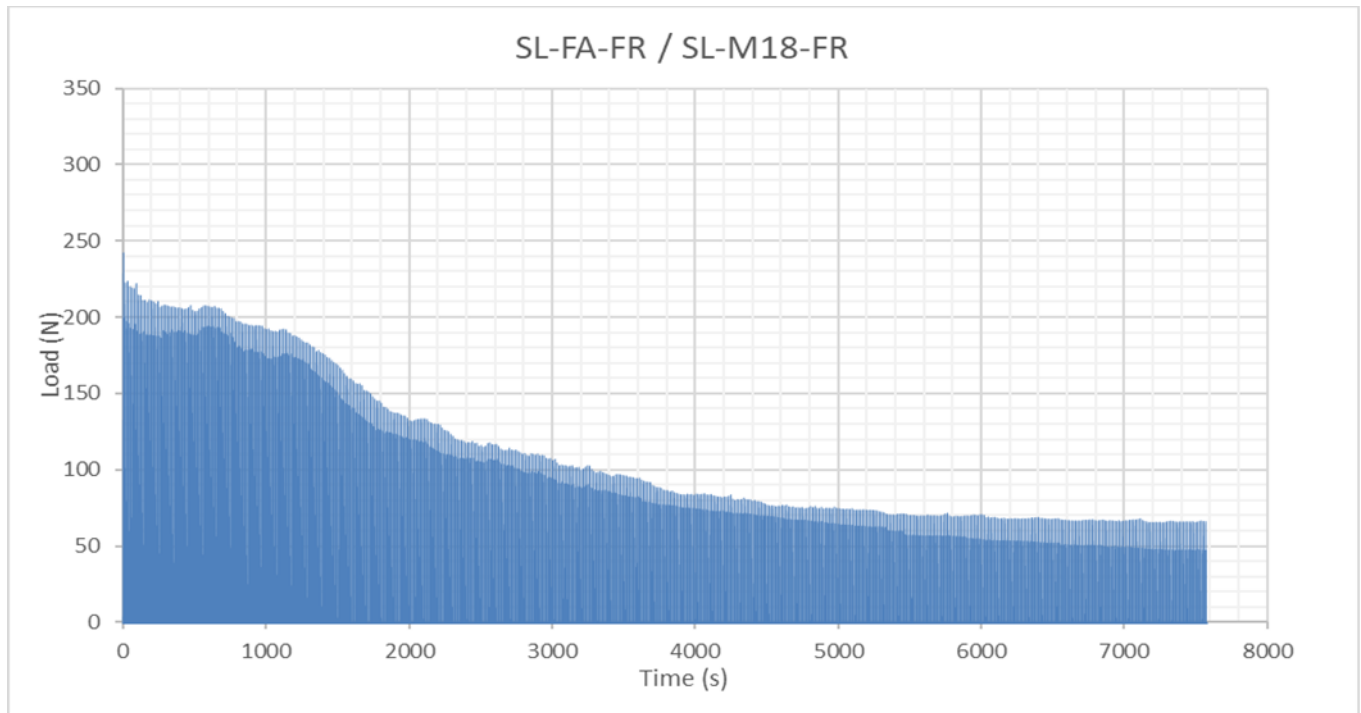
Figure 13 - Graphical representation of the SL-FA-FR / SL-M18-FR clip set pull-out test
